**Flood Control Project Maintenance  
Levee Inspections**  
**LMA District Cover Sheet**  
**Spring 2010 Levee Inspection Results**

**Reclamation District No. 0404 Boggs**

**Levee Inspection Report By Mile - Spring 2010**

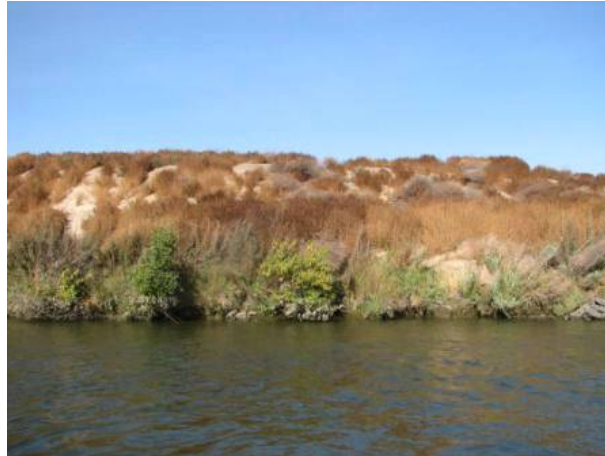
SJR2009\_S0.5 Im0.23 102108b.jpg

Levee Mile Report Line	1
Start Levee Mile	0.21
End Levee Mile	0.25
Location	Water Side
Category	Supplemental
Item	DWR Erosion Survey

2009: No major change observed; this site was combined with other existing sites at RMs 40.93, 40.98, and 41.14 as one site; several pocket erosion just above non-uniform toe rip rap; previously rated "U"; bare spots along the upper slope [2009 SiteID:RD0404U1RM40.86]

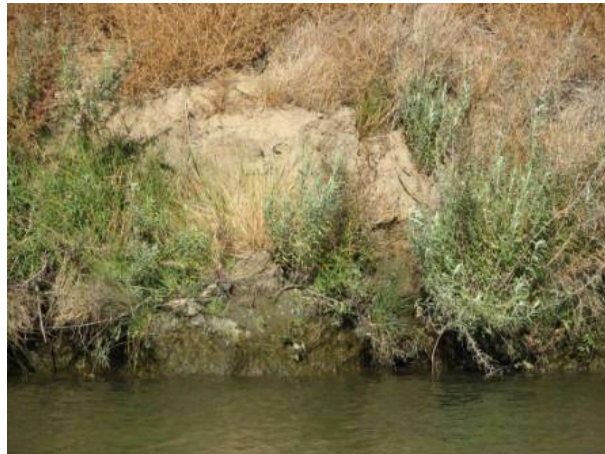
SJR2009\_S0.5 LM0.23 102108c.jpg

Levee Mile Report Line	1
Start Levee Mile	0.21
End Levee Mile	0.25
Location	Water Side
Category	Supplemental
Item	DWR Erosion Survey

2009: No major change observed; this site was combined with other existing sites at RMs 40.93, 40.98, and 41.14 as one site; several pocket erosion just above non-uniform toe rip rap; previously rated "U"; bare spots along the upper slope [2009 SiteID:RD0404U1RM40.86]

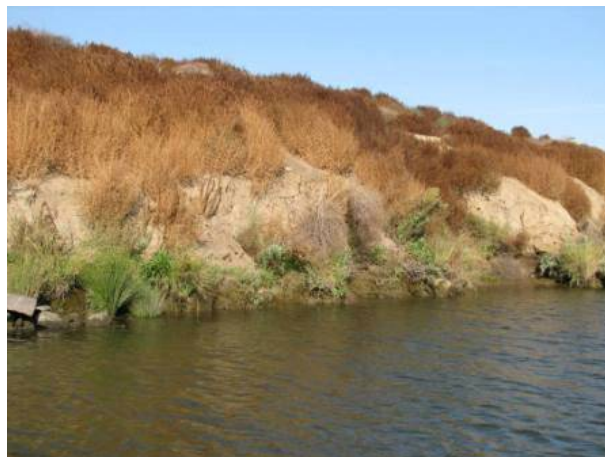
SJR2009\_S0.5 LM0.23 102108d.jpg

Levee Mile Report Line	1
Start Levee Mile	0.21
End Levee Mile	0.25
Location	Water Side
Category	Supplemental
Item	DWR Erosion Survey

2009: No major change observed; this site was combined with other existing sites at RMs 40.93, 40.98, and 41.14 as one site; several pocket erosion just above non-uniform toe rip rap; previously rated "U"; bare spots along the upper slope [2009 SiteID:RD0404U1RM40.86]

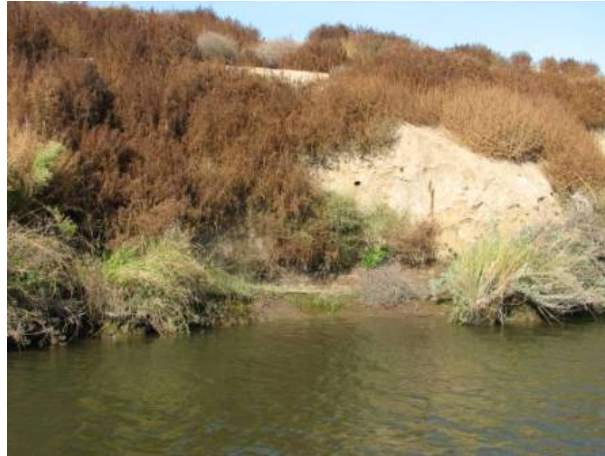
SJR2009\_S0.5 LM0.23 102108e.jpg

Levee Mile Report Line	1
Start Levee Mile	0.21
End Levee Mile	0.25
Location	Water Side
Category	Supplemental
Item	DWR Erosion Survey

2009: No major change observed; this site was combined with other existing sites at RMs 40.93, 40.98, and 41.14 as one site; several pocket erosion just above non-uniform toe rip rap; previously rated "U"; bare spots along the upper slope [2009 SiteID:RD0404U1RM40.86]

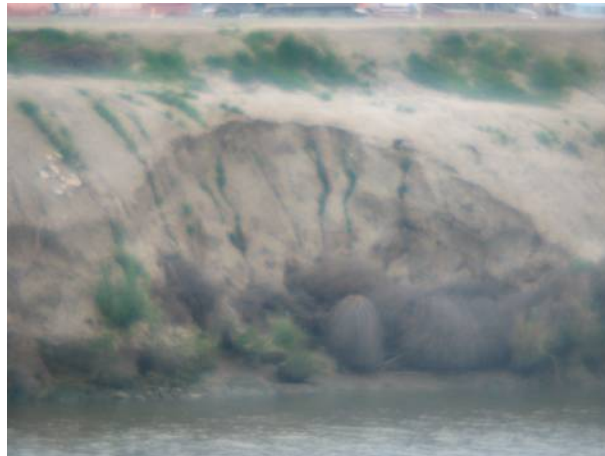
richard\_s\_20100505\_035.jpg

Levee Mile Report Line	2
Start Levee Mile	0.24
End Levee Mile	0.27
Location	Water Side
Category	Earthen Levee
Item	Erosion / Bank Caving

Erosion from LM 0.24 to 0.27

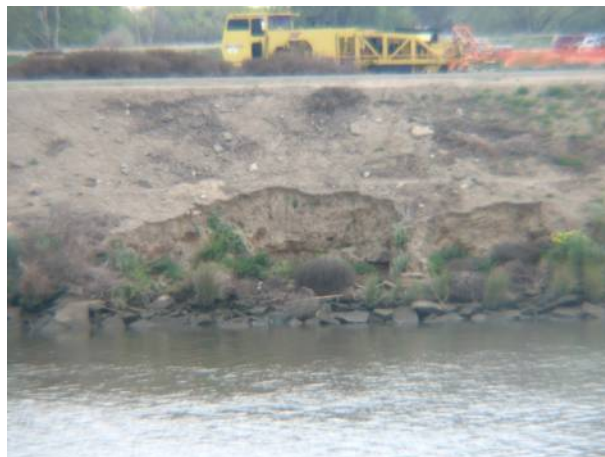
richard\_s\_20100505\_036.jpg

Levee Mile Report Line	2
Start Levee Mile	0.24
End Levee Mile	0.27
Location	Water Side
Category	Earthen Levee
Item	Erosion / Bank Caving

Erosion at LM 0.27

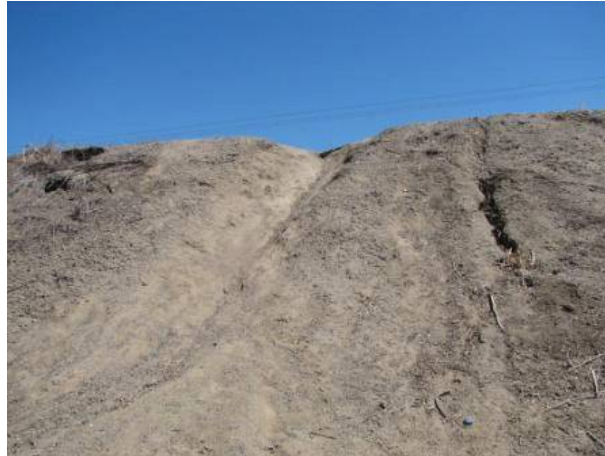
SJR2009\_RM1.56a.JPG

Levee Mile Report Line	4
Start Levee Mile	1.32
End Levee Mile	1.58
Location	Water Side
Category	Supplemental
Item	DWR Erosion Survey

2009: Erosion appears to be maintenance-related, and not cause by riverflow; recommend annual assessment and monitoring of erosion site, per Critical Erosion Sites Evaluation 2008 Report; previously rated "U" [2009 SiteID:RD0404U2RM1.56]

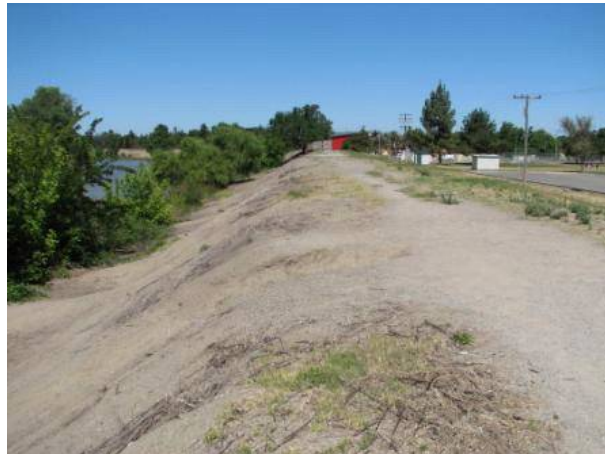
SJR2009\_RM1.56b.JPG

Levee Mile Report Line	4
Start Levee Mile	1.32
End Levee Mile	1.58
Location	Water Side
Category	Supplemental
Item	DWR Erosion Survey

2009: Erosion appears to be maintenance-related, and not cause by riverflow; recommend annual assessment and monitoring of erosion site, per Critical Erosion Sites Evaluation 2008 Report; previously rated "U" [2009 SiteID:RD0404U2RM1.56]

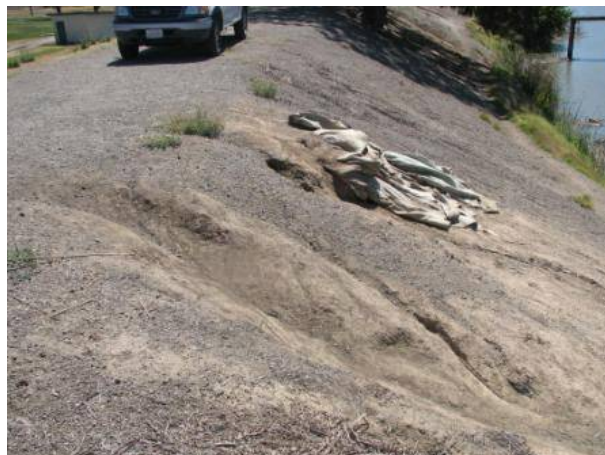
SJR2009\_RM1.56c.JPG

Levee Mile Report Line	4
Start Levee Mile	1.32
End Levee Mile	1.58
Location	Water Side
Category	Supplemental
Item	DWR Erosion Survey

2009: Erosion appears to be maintenance-related, and not cause by riverflow; recommend annual assessment and monitoring of erosion site, per Critical Erosion Sites Evaluation 2008 Report; previously rated "U" [2009 SiteID:RD0404U2RM1.56]

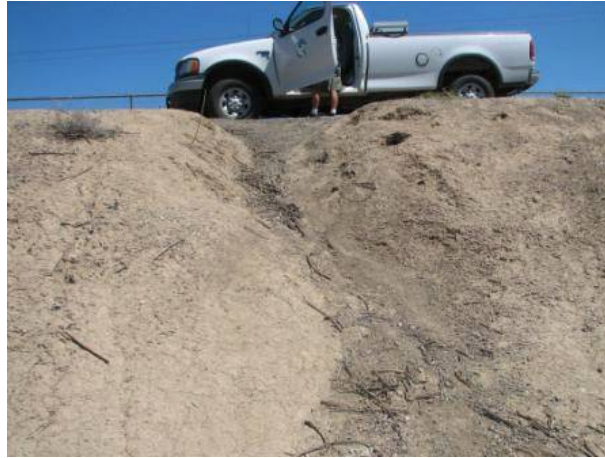
SJR2009\_RM1.56d.JPG

Levee Mile Report Line	4
Start Levee Mile	1.32
End Levee Mile	1.58
Location	Water Side
Category	Supplemental
Item	DWR Erosion Survey

2009: Erosion appears to be maintenance-related, and not cause by riverflow; recommend annual assessment and monitoring of erosion site, per Critical Erosion Sites Evaluation 2008 Report; previously rated "U" [2009 SiteID:RD0404U2RM1.56]

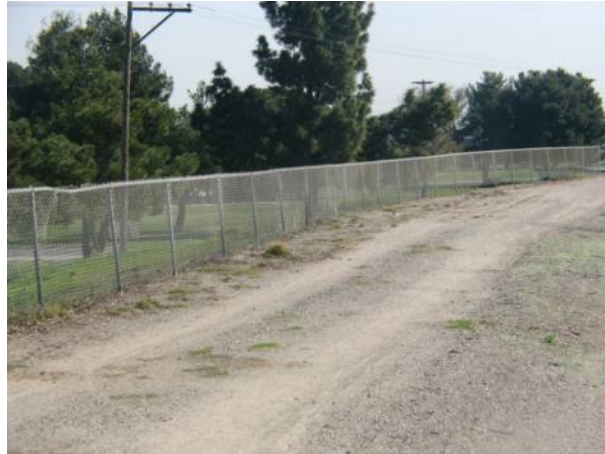
richard\_s\_20100505\_037.jpg

5	1.47	1.52	Earthen Levee	Encroachments	LS	PO	Fences	37.918440 ° -121.296707 °	37.918517 ° -121.295763 °	6 Y

Levee Mile Report Line	5
Start Levee Mile	1.47
End Levee Mile	1.52
Location	Land Side
Category	Earthen Levee
Item	Encroachments

Fence at landside shoulder from LM 1.47 to 1.52
